PASSAIC RIVER BASIN
FOXES BROOK, MORRIS COUNTY
NEW JERSEY

FOXES LAKE DAM

NJ 00342

**PHASE 1 INSPECTION REPORT
NATIONAL DAM SAFETY PROGRAM**

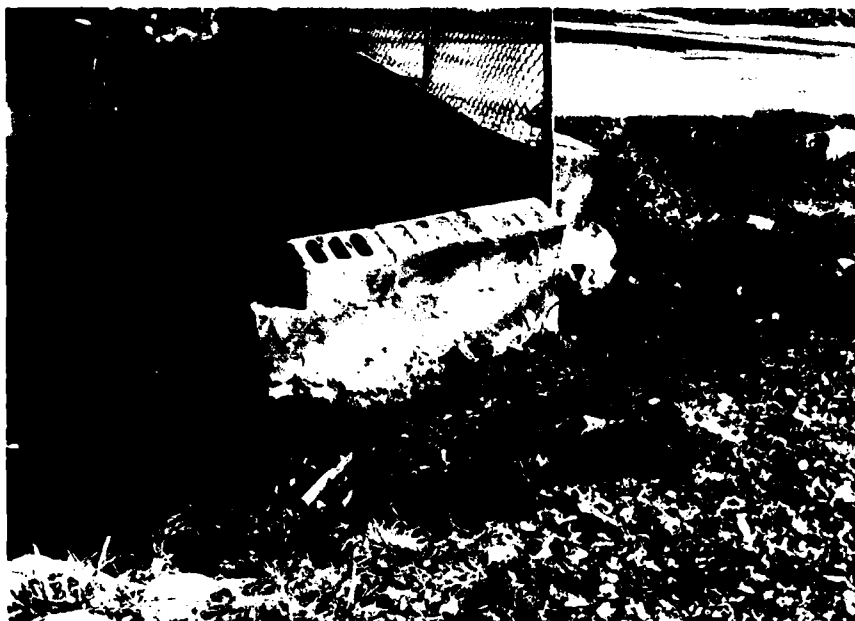
c. Visual Observations. Some erosion of the upstream face of the dam embankment at the west side of the principal spillway structure was observed. This has left the short concrete block training wall at the west side of the spillway virtually non-functional. No evidence of overtopping of the dam crest was noted.

Erosion of the upstream slope of the dam and of the west abutment next to the concrete wall which retains the downstream side of the embankment could lead to breaching of the dam if not controlled. The poor condition of the riprap on the upstream slope has contributed to the erosion problem. The lack of vegetation on the crest of the dam makes the crest susceptible to severe erosion if the dam should be overtopped. The unevenness of the crest may be a sign of internal conditions which could adversely affect the stability of the embankment. If trees that are growing on the upstream slope blow over and pull out their roots or if trees die and their roots rot, serious seepage and erosion problems could result. Spalling, erosion, and cracking of the concrete spillway, channel walls and retaining walls could lead to instability of the structure if the deterioration continues.

Looking east across upstream face at entrance to principal spillway. Note undermined training wall and embankment erosion.

(1) Design or specify and oversee repairs for the erosion that has occurred on the upstream slope and on the west abutment.
